TS-PIC-88710
May 1988

AERIAL PHOTOGRAPHIC ANALYSIS OF THE COMBE FILL SOUTH LANDFILL Chester, New Jersey

AERIAL PHOTOGRAPHIC ANALYSIS OF THE COMBE FILL SOUTH LANDFILL

Chester, New Jersey

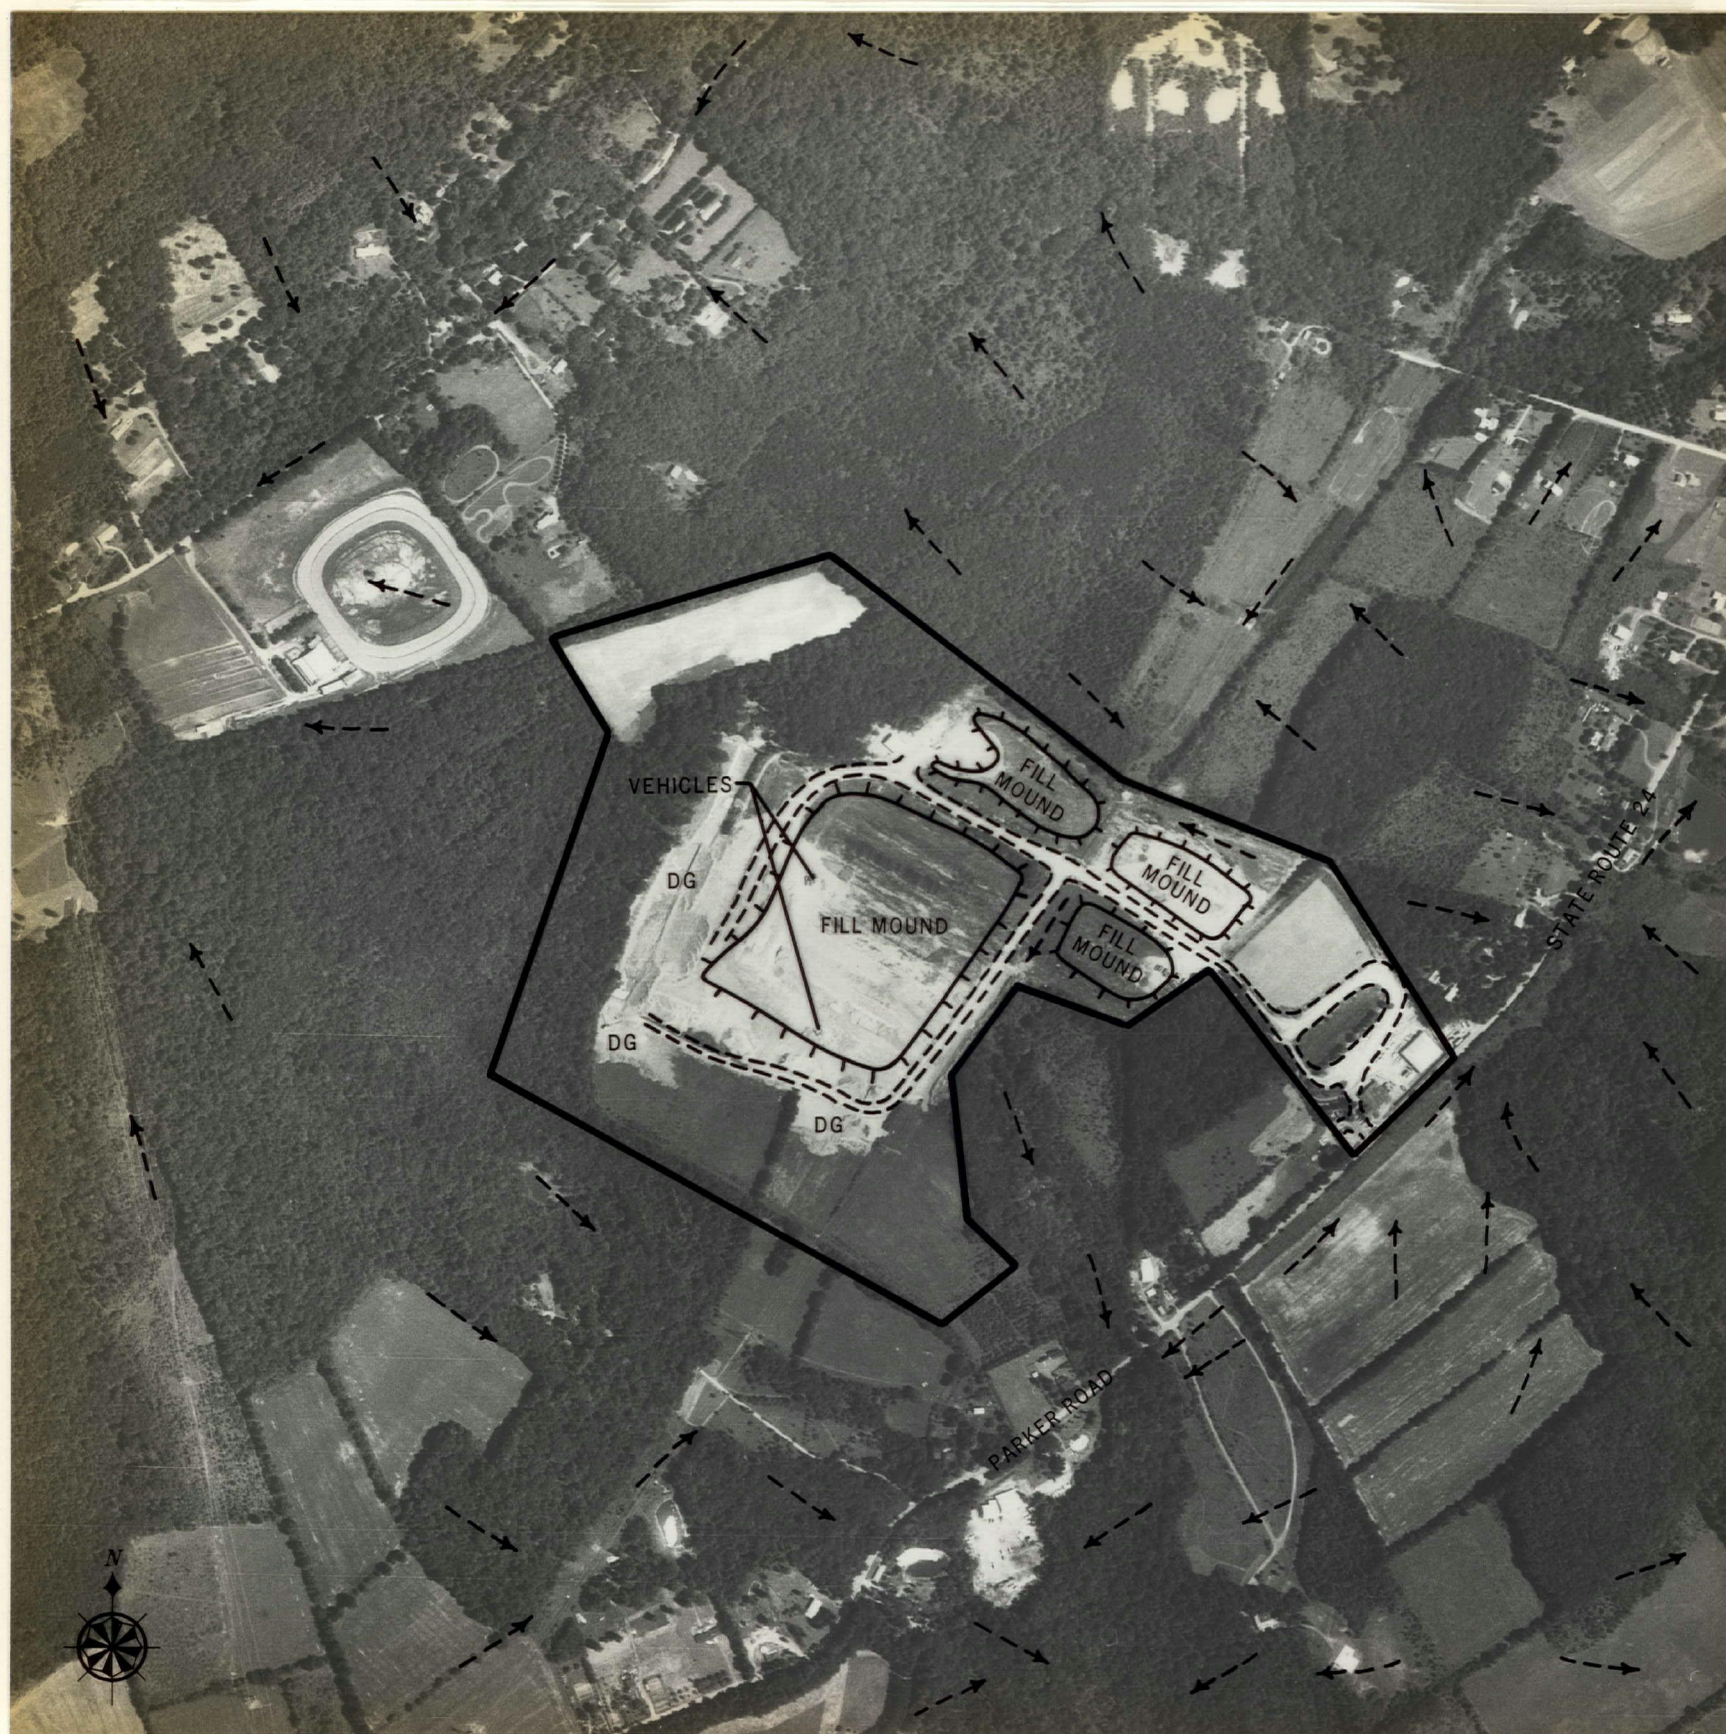
Figure 10. Combe Fill South Landfill, July 7, 1979. Approximate scale 1:8,300.

Continued dumping activity is noted at the Combe Fill South Landfill. It appears the southeastern mound has received recent cover material. The adjacent mound has partially revegetated. The northeastern mound also has sparse vegetation growth. It appears some excavation activity is going on at the northern end of this mound. The large mound has expanded further to the southwest, reflecting activity noted in this area on the 1974 photo coverage (Figure 9). The top of this mound has a "washboard" type appearance indicating a possible trench-type burial activity in the past. Several heavy duty type vehicles are noted on the mound indicating possible ongoing burial activity.

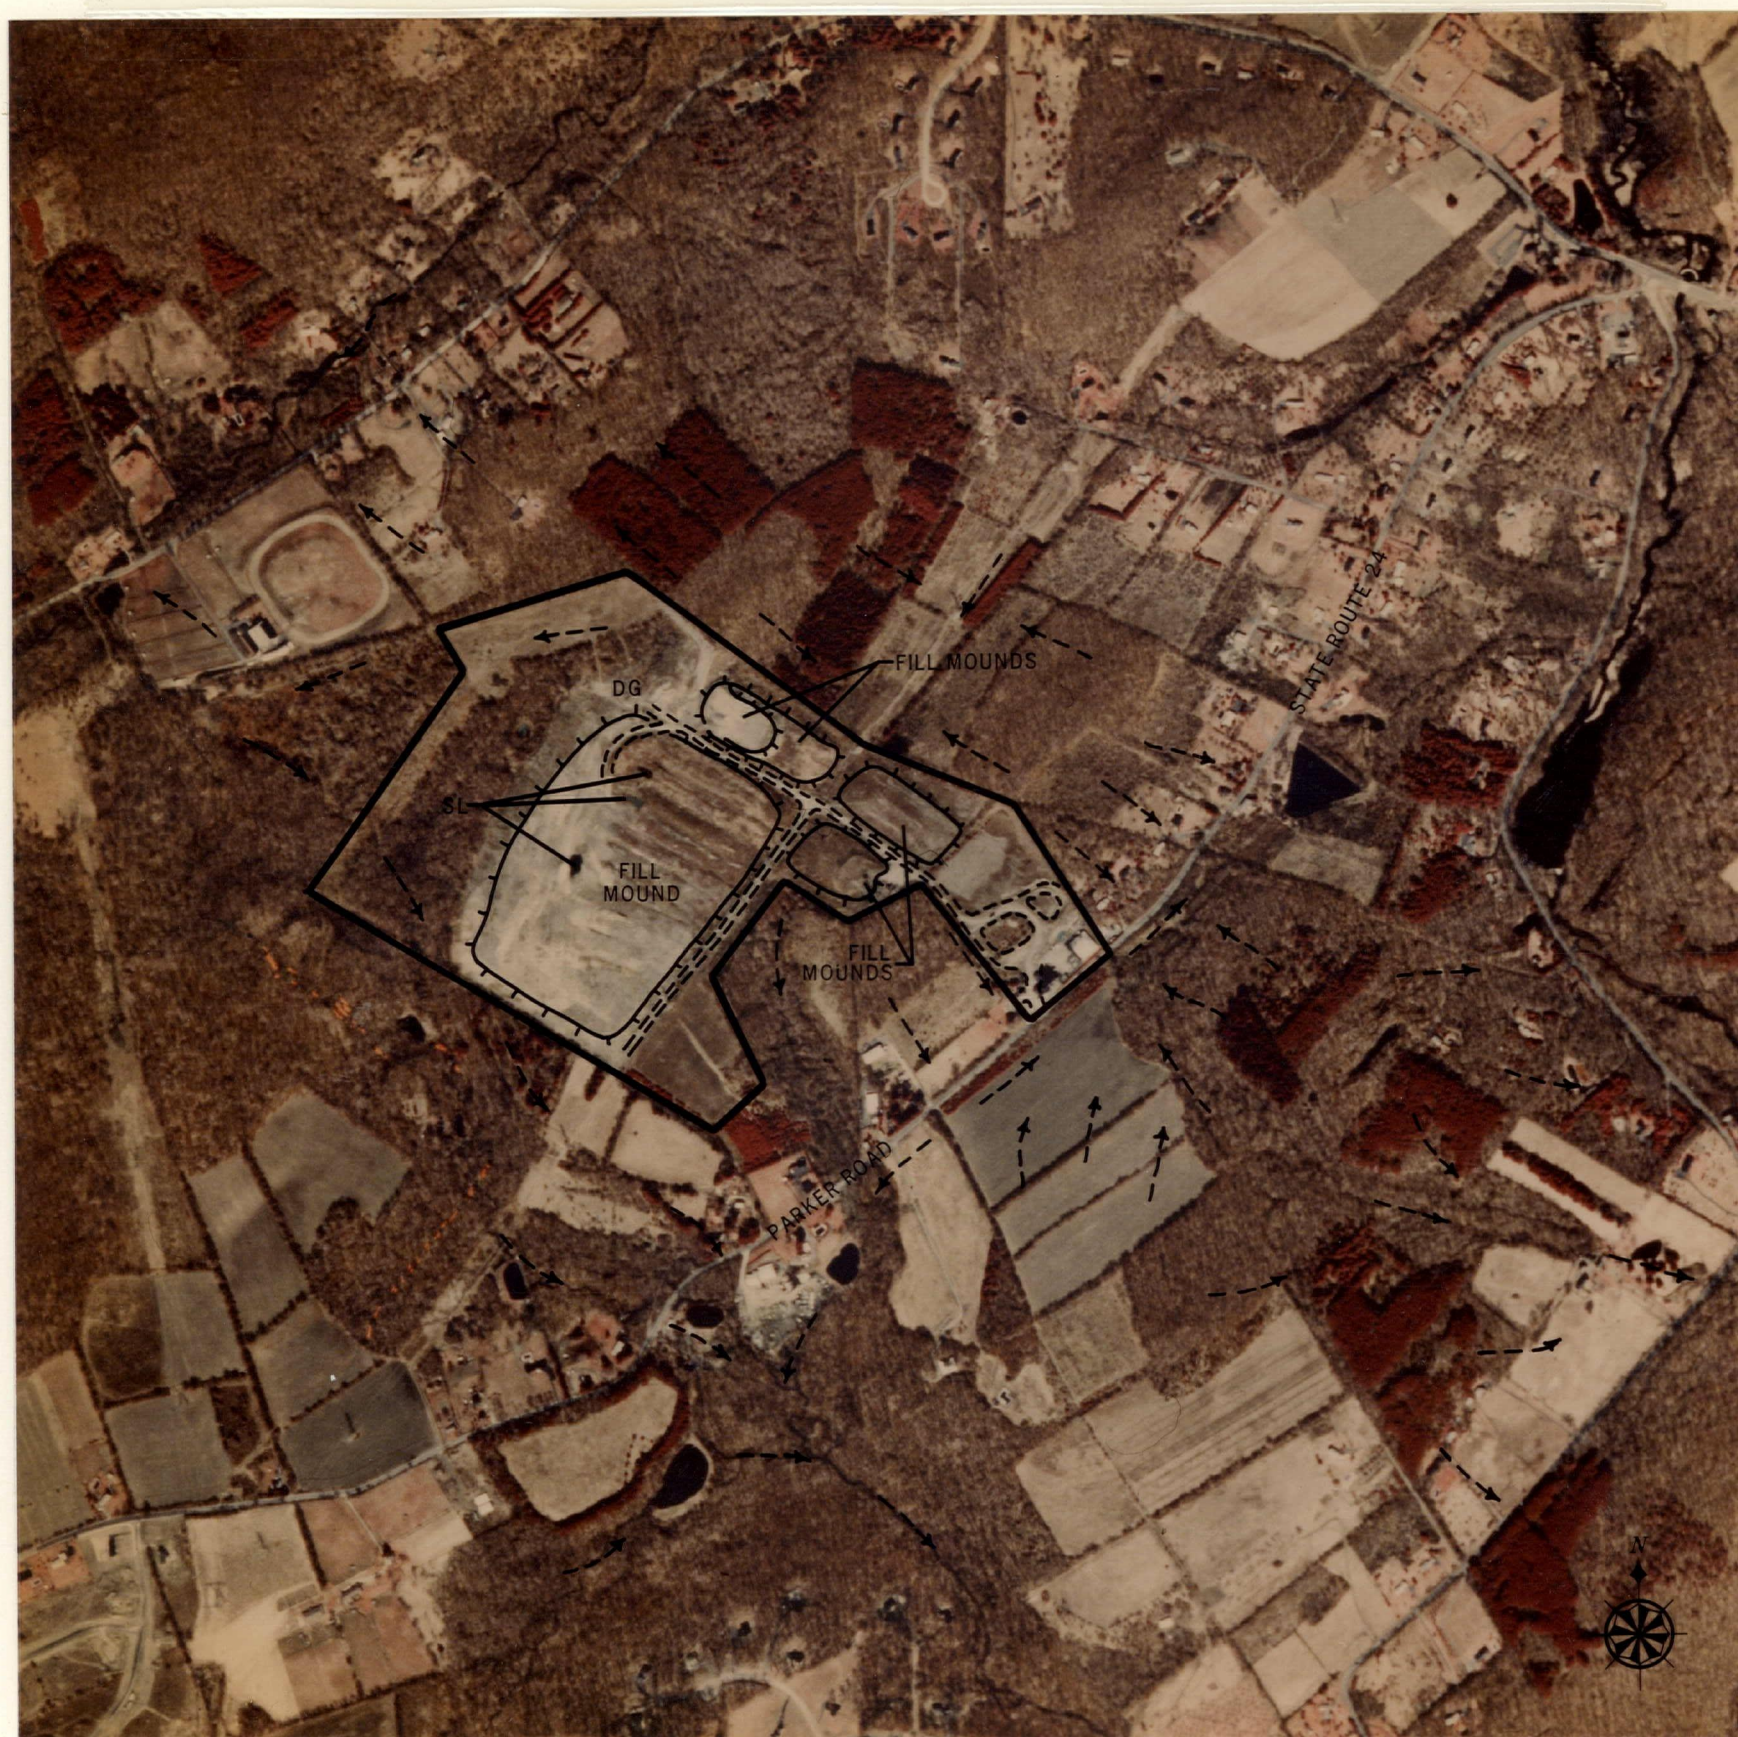
Figure 11. Combe Fill South Landfill, March 26, 1984. Approximate scale 1:13,750.

This high-altitude, color infrared photograph shows that the Combe Fill South Landfill is still active. The two southeastern mounds appear inactive and have a sparse vegetative growth cover. An additional layer has been added to the fill mound just to the north of these. It appears recent cover material has been applied to this new layer. The large fill mound has expanded further to the southwest. The top of this mound still shows the corrugated, washboard-type pattern associated with trench-typed disposal operations. Three pools of standing liquid are visible atop this mound. Vehicular activity along the access road to the fill areas indicates possible ongoing dumping activity.

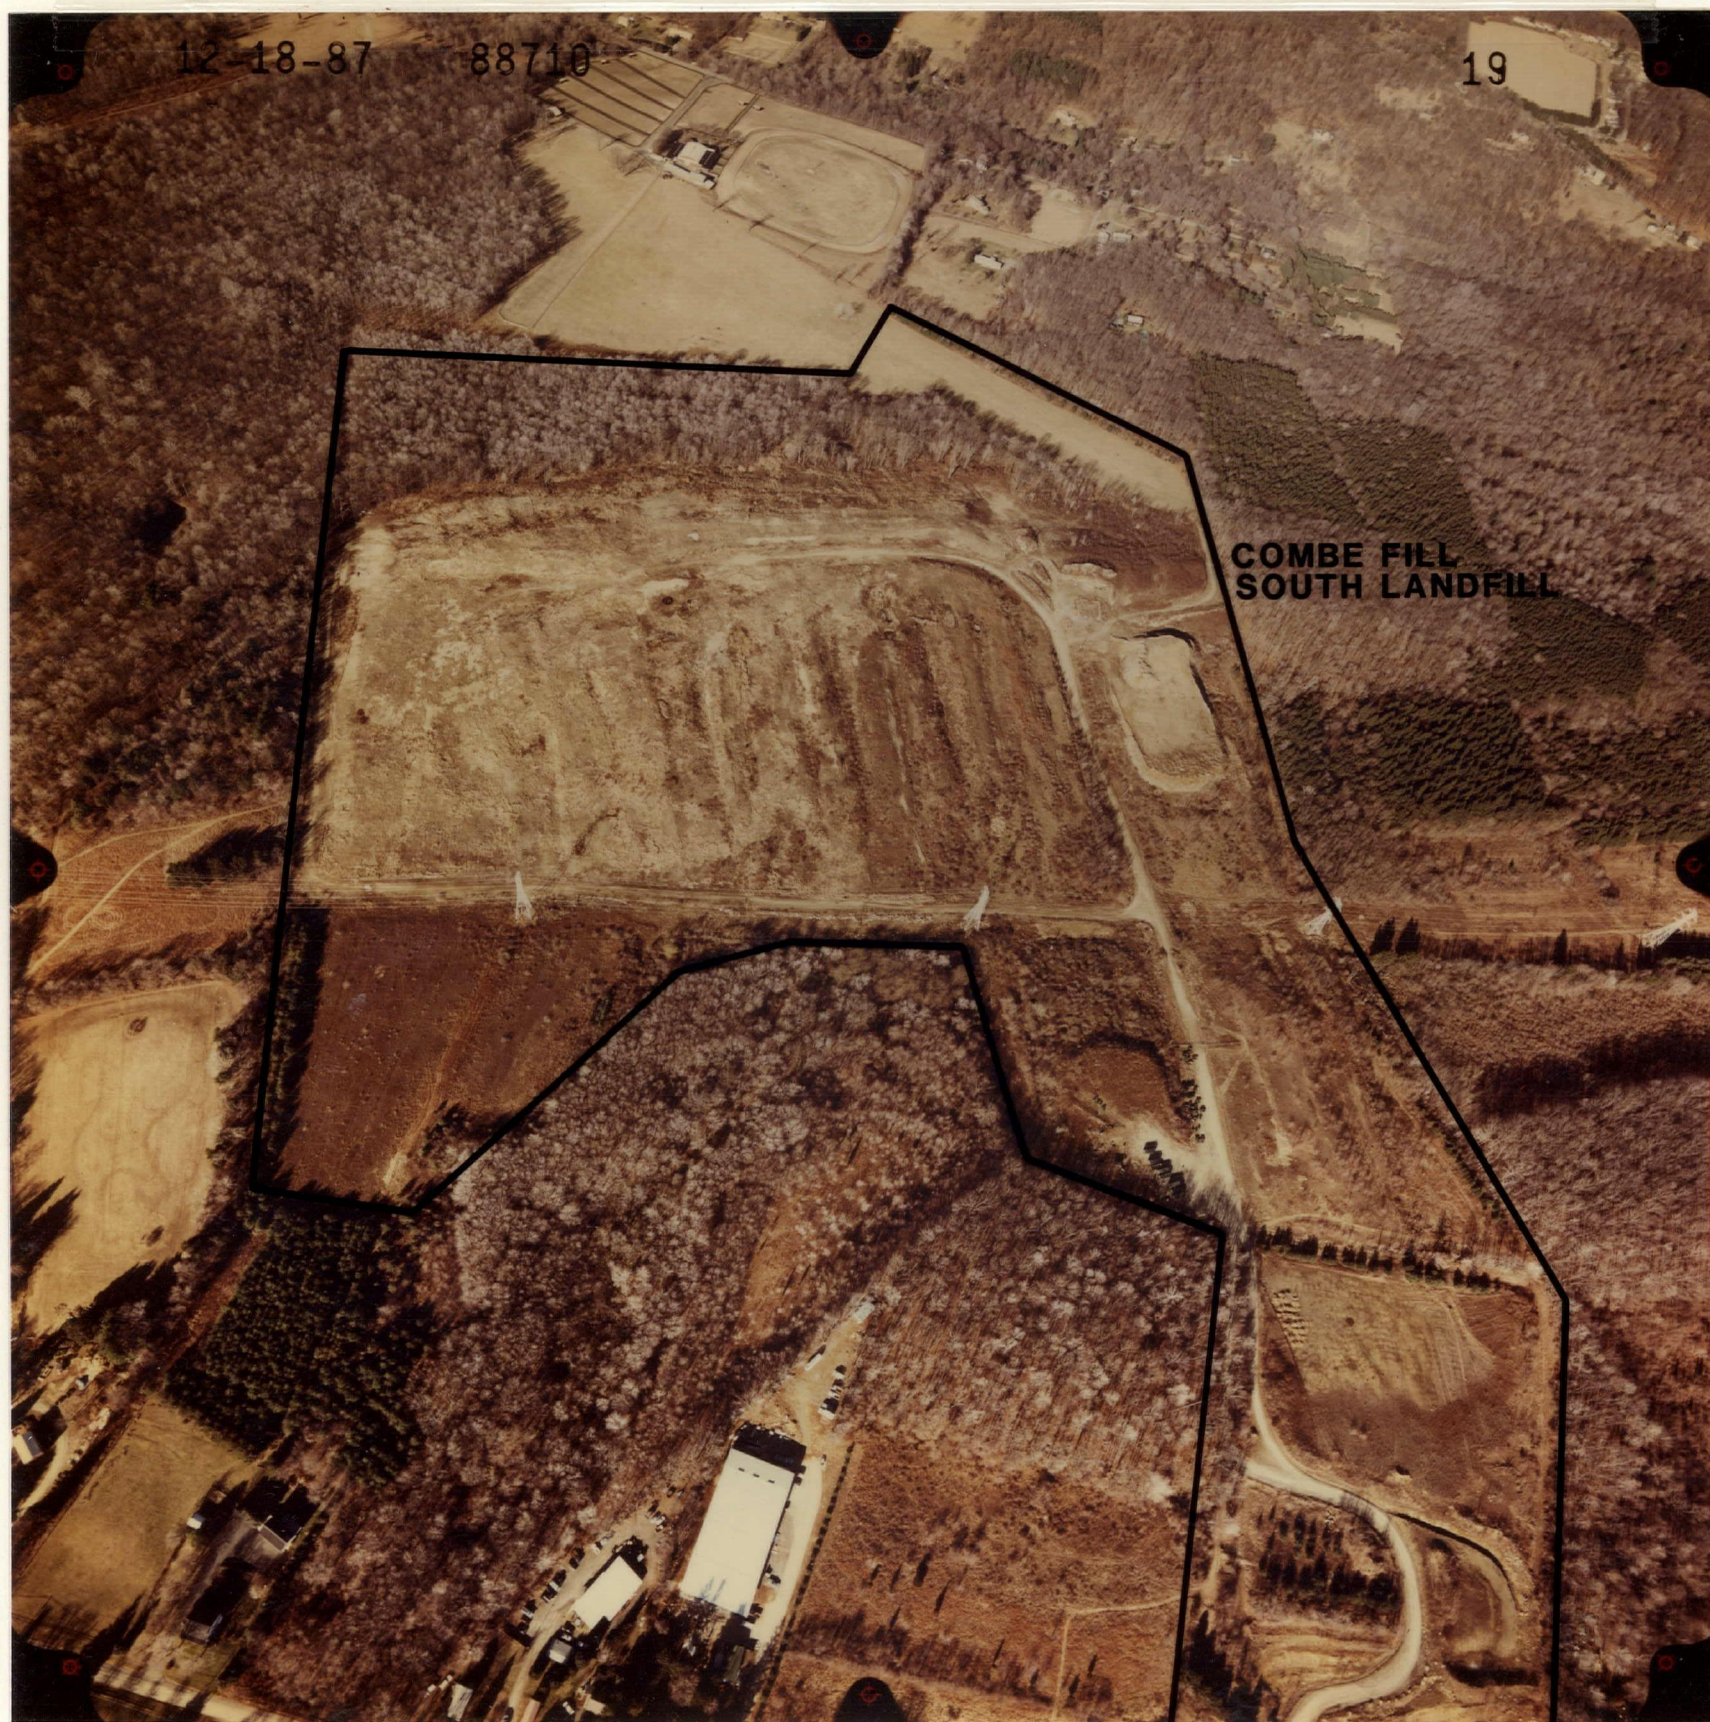
Figure 13. Combe Fill South Landfill, December 18, 1987. Oblique looking northwest.

This photograph presents an oblique view of the Combe Fill South Landfill.
The scene is looking to the northwest.
